# Condition Assessment Report

Portsmouth Civic Center Complex

April 29, 2019

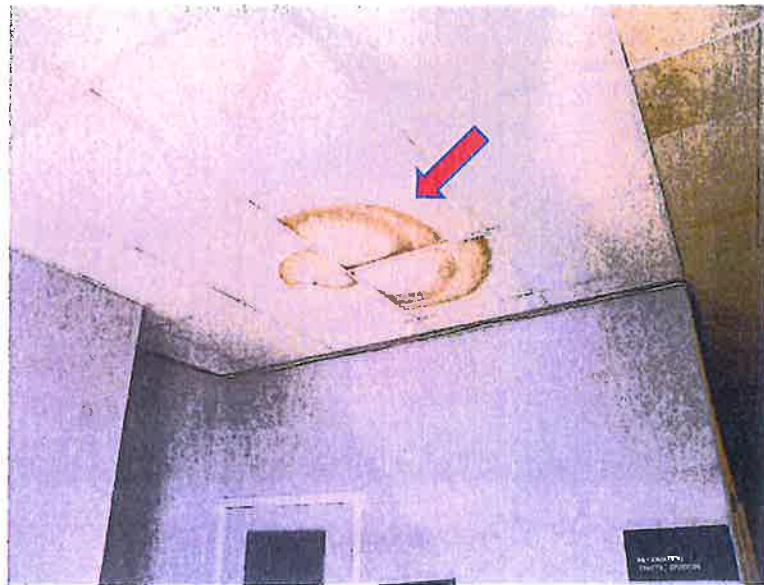
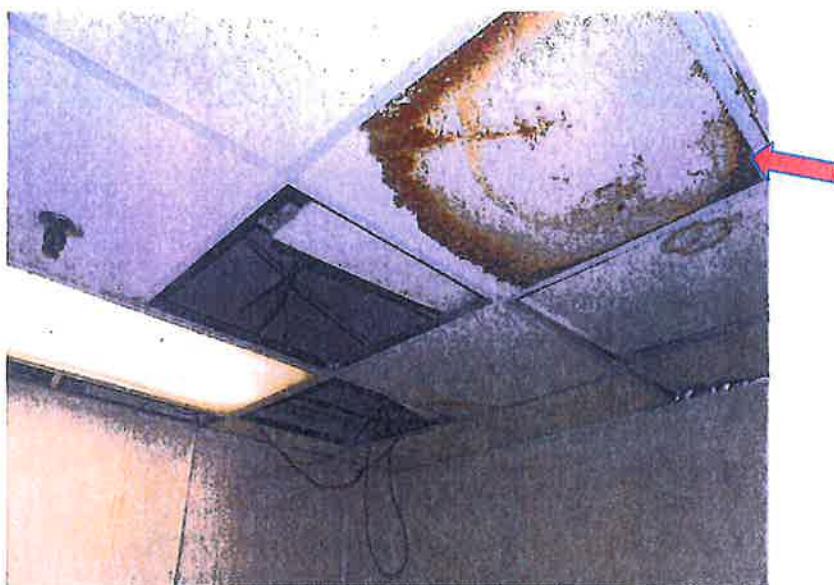
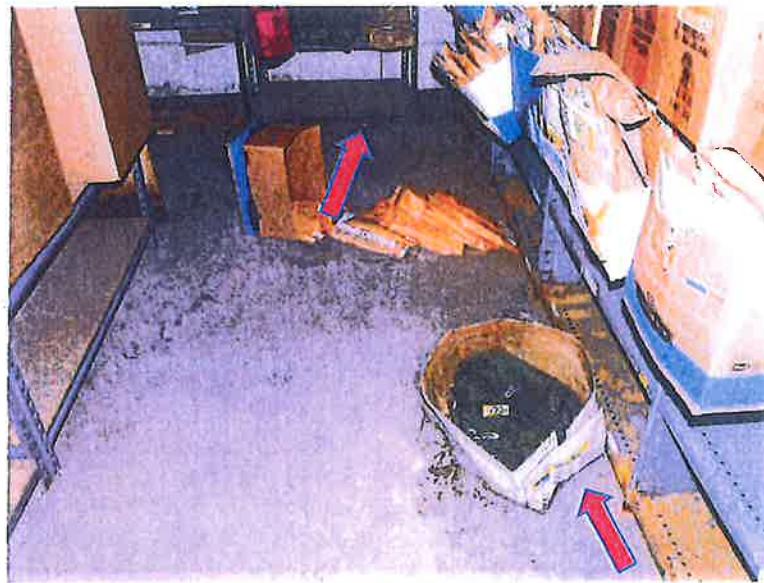
It is apparent that the roof, exterior walls and windows leak badly. See photos HQ-1 through HQ-14. Although it may not be obvious, the center area ceiling in some areas has fallen or sunken approximately 6" below the adjacent ceiling areas. See photo HQ-8. Water leaks in the basement area Police Evidence storage spaces show significant flooding over an extended length of time. See photos HQ-11, HQ-12, HQ-13 & HQ-14. Some of the exterior wall and window leaks can be attributed to the apparent use of non-water proof construction to fill a former window opening after a residential window style air conditioner was installed. See photo HQ-15.

- Replace and replace all existing roofing and flashing.
- Remove residential window mounted air-conditioning unit. Provide a commercial equivalent which does not have to be window mounted. Remove plywood closure. Replace all windows with thermally broken window systems and energy efficient glazing.
- Provide code compliant vapor and thermal barrier systems at all exterior surfaces.
- Demolish all existing water damaged interior partitions/ finishes and replace with new to suit current use.
- Inspect all exterior precast concrete elements and replace damaged sections and/or attachments.
- Replace previously removed precast concrete elements to match existing.
- Renovate existing elevator systems.

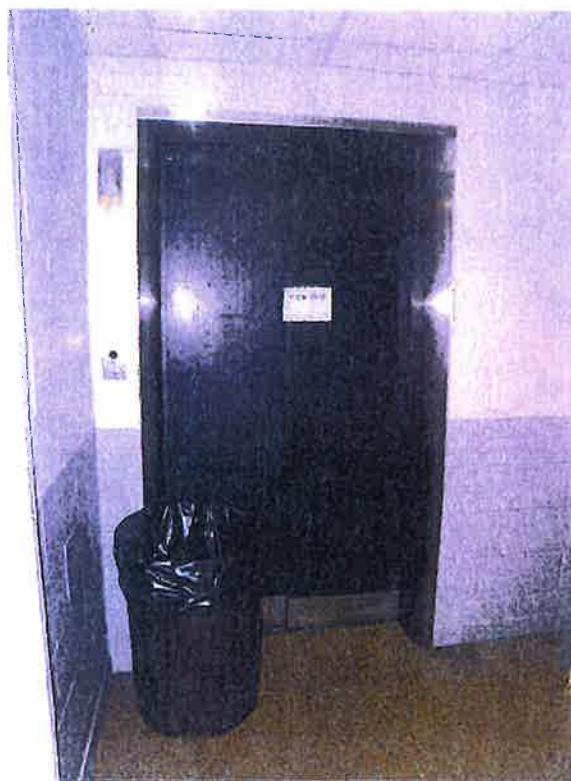
Photo -HQ18

The publicly accessible elevator servicing the building is not in working order. See photo HQ-18.

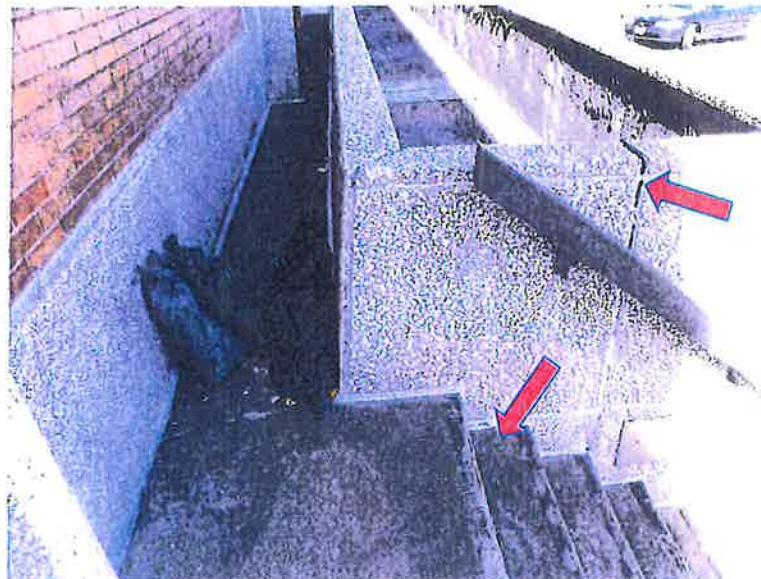
Photo -PL1

All construction appears to be original to the complex with only minor maintenance consisting primarily of sealant at joints between the precast concrete panels. This sealant appears to have exceeded its useful life span and is failing. See photo PL-1

- Remove all precast concrete pediment wall and paver panels. Remove and replace all existing waterproofing. Provide new precast concrete pediment wall and paver panels to match existing.
- Remove and replace all water proofing in planters.
- Repair and/or replace existing plaza level and planter drainage piping as required to provide proper operation.

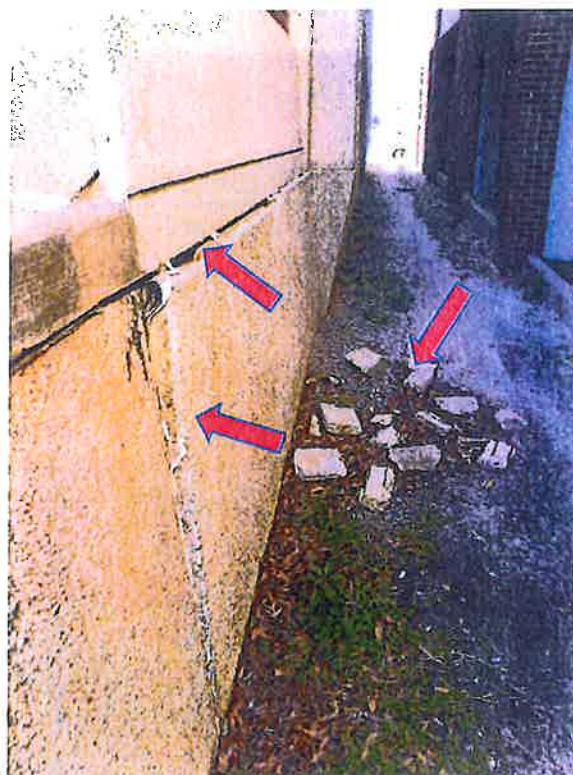
Photo -PL2

Based on evidence of significant water leaks at the Basement Level of the complex it appears the original waterproofing under the perimeter precast concrete walls and walkway panels have failed and, in some areas, precast panel steel anchors have become exposed and are rusting which has allowed precast concrete elements to loosen and, in several locations, fall off the building. See photos, PL-2, PL-3, PL-4, PL-5, PL-6 & PL-7

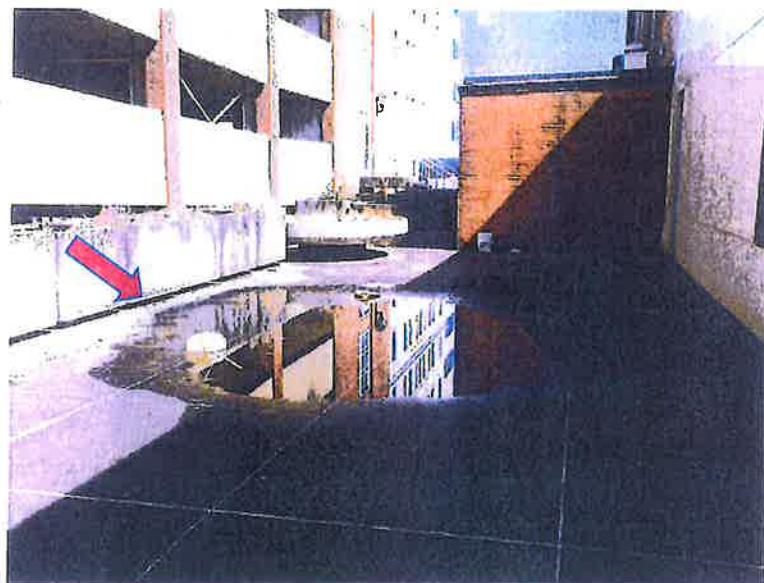
The plaza level drainage system is not functioning properly. This is evident by the fact it had not rained in several days prior to our field investigation and standing water was visible in several locations. This is undoubtably contributing to the basement level leaks. See photos PL-8 & PL-9.

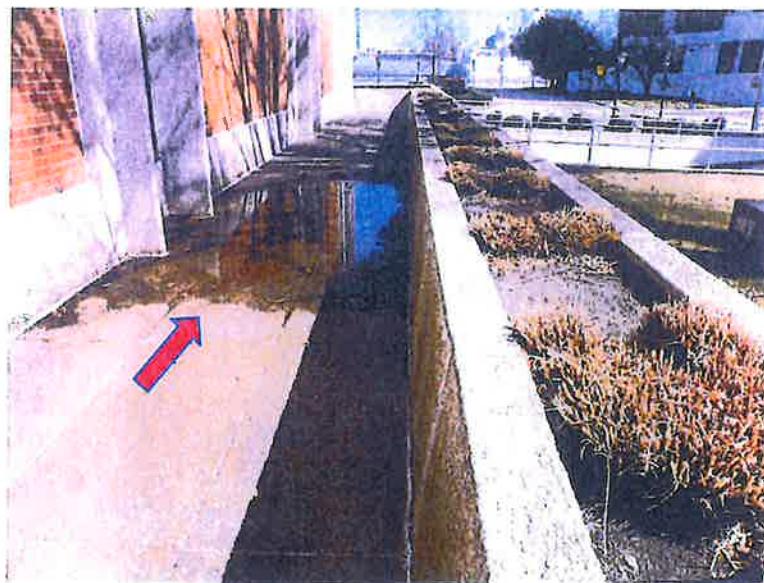
As previously noted, the perimeter of the plaza level is lined with precast concrete planter boxes. These planter boxes have a water proofing membrane and internal drains. A few contain soil and plantings but most are empty, except for trash and the water proofing membrane is exposed and obviously failing. One of the planter boxes is filled with water. See photos PL-10 & PL-11.

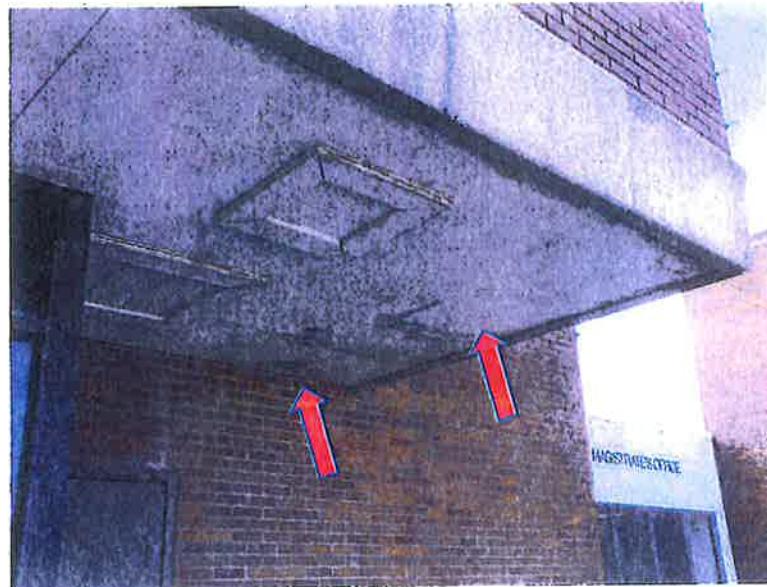
The exterior brick and precast concrete elements jail appear to be in good and serviceable condition but after further investigation appears to be holding a significant amount of water. Although, it was well above freezing during our field investigation a large ice formation had grown down from the Jail tower. See photo J-1. Excessive water under the brick is also evident by extensive efflorescence on the east side of the building. See photo J-2. Extensive finish discoloration and water stains are also visible on several of the plaza level soffits. See photos J-3 & J-4.

- Replace existing plaster soffits under inmate tower to match existing.
- Replace existing storefront system at plaza level with a thermally broken system with energy efficient glazing.

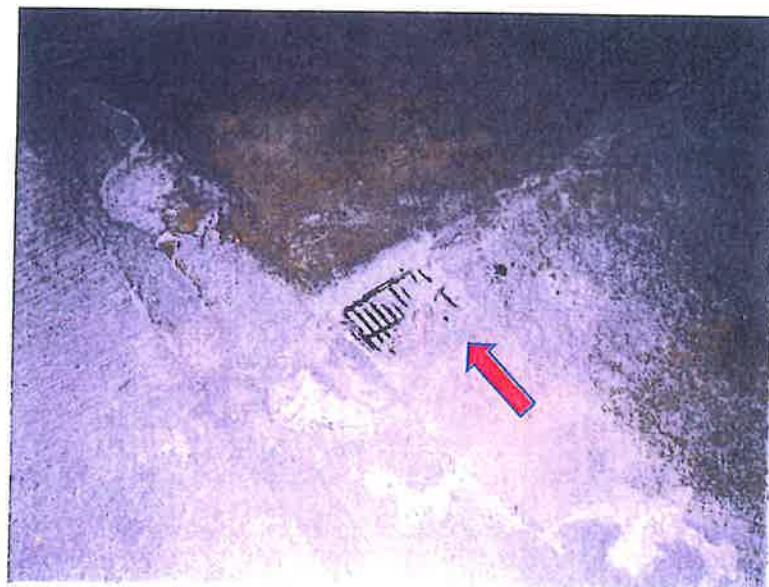
Photo -G2

Due in part to the 24-hour per day, 7-day a week operation of the Portsmouth Police Department, the Police basement parking area floor is subjected to significant wear from Police and Sheriff department vehicle traffic loading on the basement floor pavement. Some of the concrete slabs have been repaired. See photo G-1. As these concrete slabs continue to wear, concrete debris covers the floor slabs and this debris has filled and clogged the floor drains to the point they no longer function. See photo G-2.

- Repair and/or replace existing reinforced masonry concrete construction damaged by water.
- Repair all fire rated construction.
- Replace all existing water damaged interior partitions/ finishes.
- Repair and/or replace existing drainage piping as required to provide proper operation.

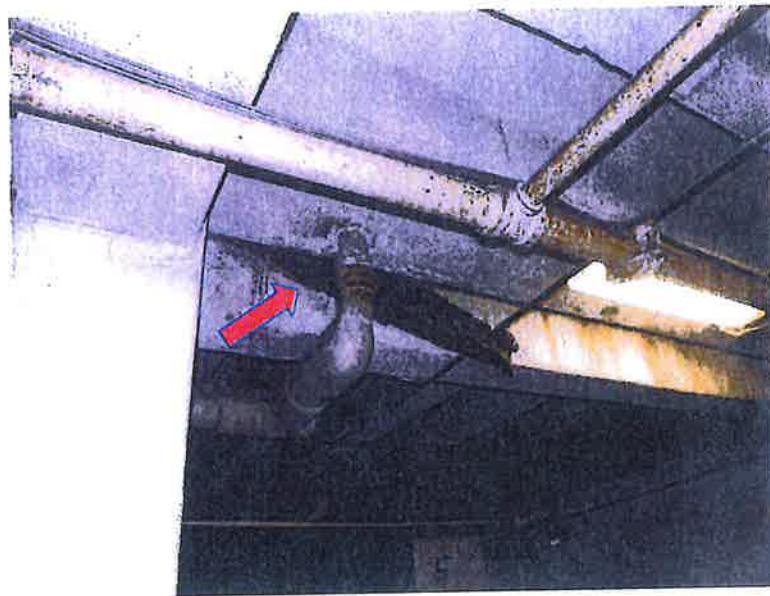
As previously referenced, water leaks from the Plaza Level have significantly deteriorated the concrete structure of the poured in place concrete Plaza Level floor and Basement Level overhead structure. See photos G-3 & G-4. As previously noted, it had not rained for several days prior to our site investigation but running and standing water was visible. In one area water was leaking onto and standing around a large electrical transformer. See photos B-5 & B-6. This ongoing and deteriorating condition is evident by the
